Date: December 5, 2013

ENERGY STUDY FOR SLATE LIBRARY

332 Main Road
Gill, MA 01354

Bales Energy Associates, an energy efficiency engineering firm, was contracted to provide an ASHRAE Level 2 energy audit for the Slate Library located at 332 Main Road in Gill, Massachusetts.

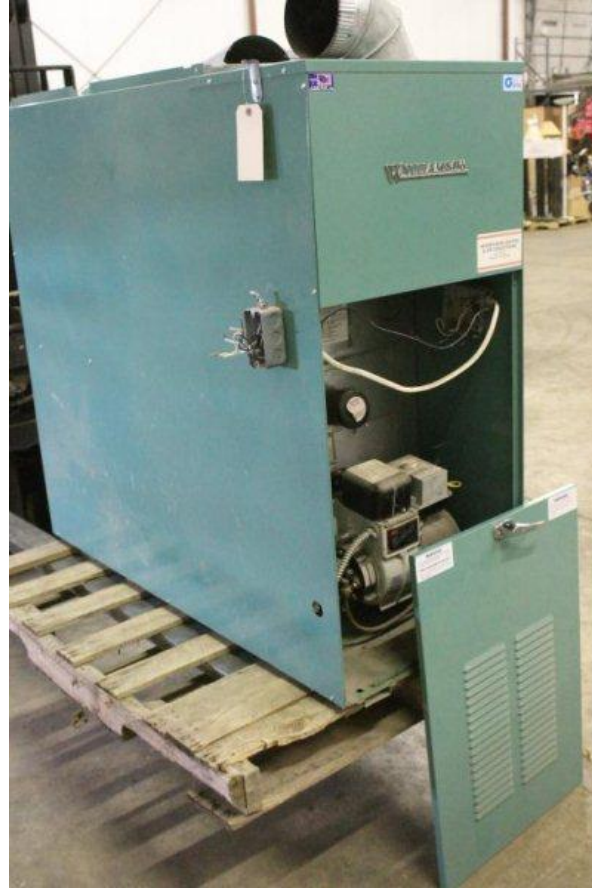
EXISTING FURNACE

Williamson Furnace of Same Type as Existing Furnace at Slate Library

The building is served by an atmospheric, oil-fired, non-condensing hot air furnace (Williamson WLBO-105) installed in 1999. This single-firing rate boiler has an output heating capacity of 105,000 Btu/hr. The boiler has a measured combustion efficiency of 82%.

Bales Energy Associates recommends replacement of the existing oil-fired, atmospheric furnace with a sealed combustion, propane-fired, condensing furnace and the installation of a town-owned propane storage tank.

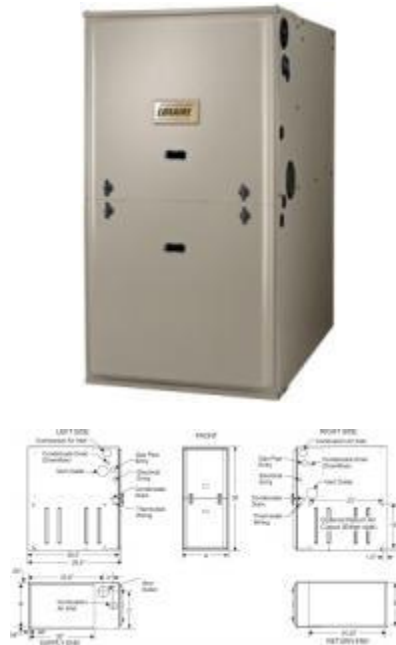
Gas Furnace TM9V LX Series TM9V060 B12MP11

Details for LX Series TM9V060 B12MP11:

96% 2 Stage Variable Speed Multi-Position Gas Furnace

These compact units employ induced combustion, reliable hot surface ignition and high heat transfer aluminized tubular heat exchangers. The units are factory shipped for installation in upflow or horizontal applications and may be converted for downflow applications.

- b. **Option 1: Replace the existing oil-fired atmospheric furnace with a sealed combustion, propane-fired, condensing furnace. Install a town-owned propane storage tank.**
